KDHE SECTOR ASSESSMENT DECISION

SITE/FACILITY NAME: Standard Products, Inc. (Former)

Unified Focused Assessment Report

Standard Products, Inc.
(Former)
650 East Gilbert Street
Wichita, Kansas

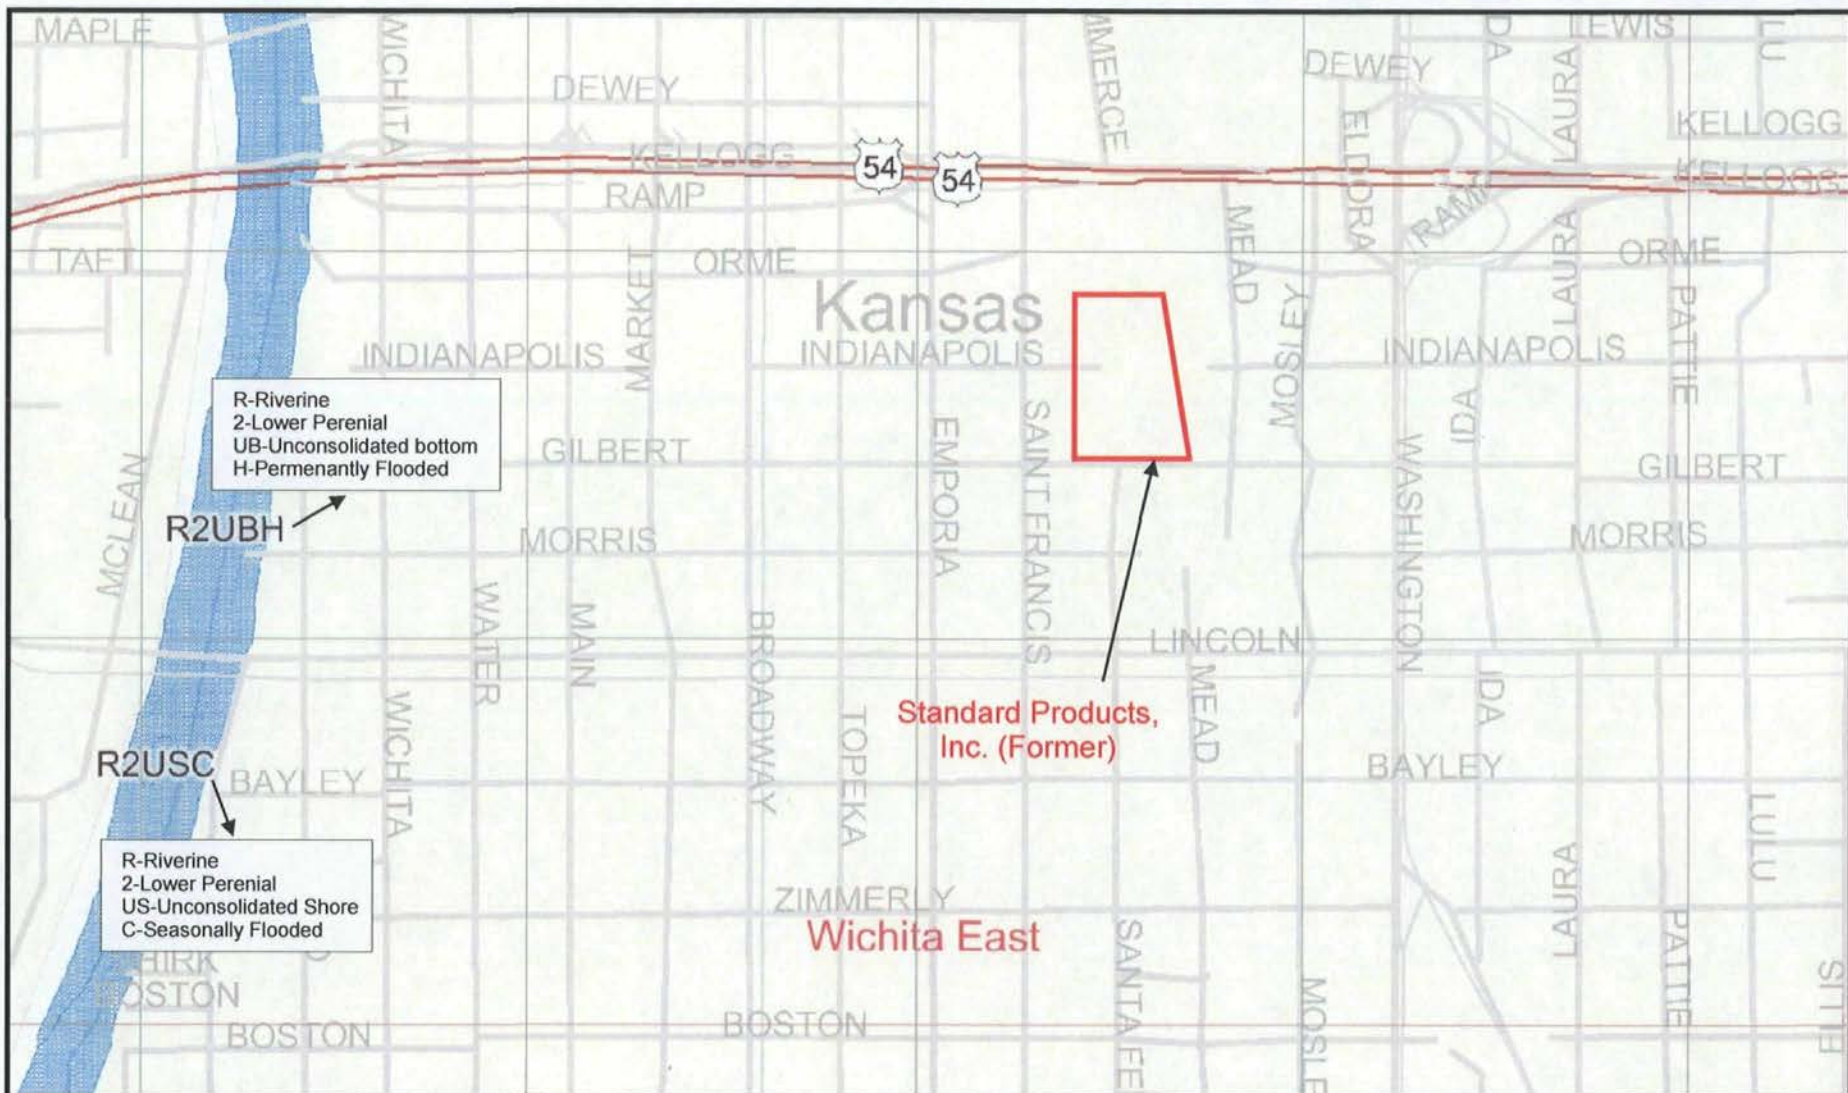
Archive Photo 1950 with
Superimposed Sample Locations
Standard Products, Inc.
Wichita, Kansas

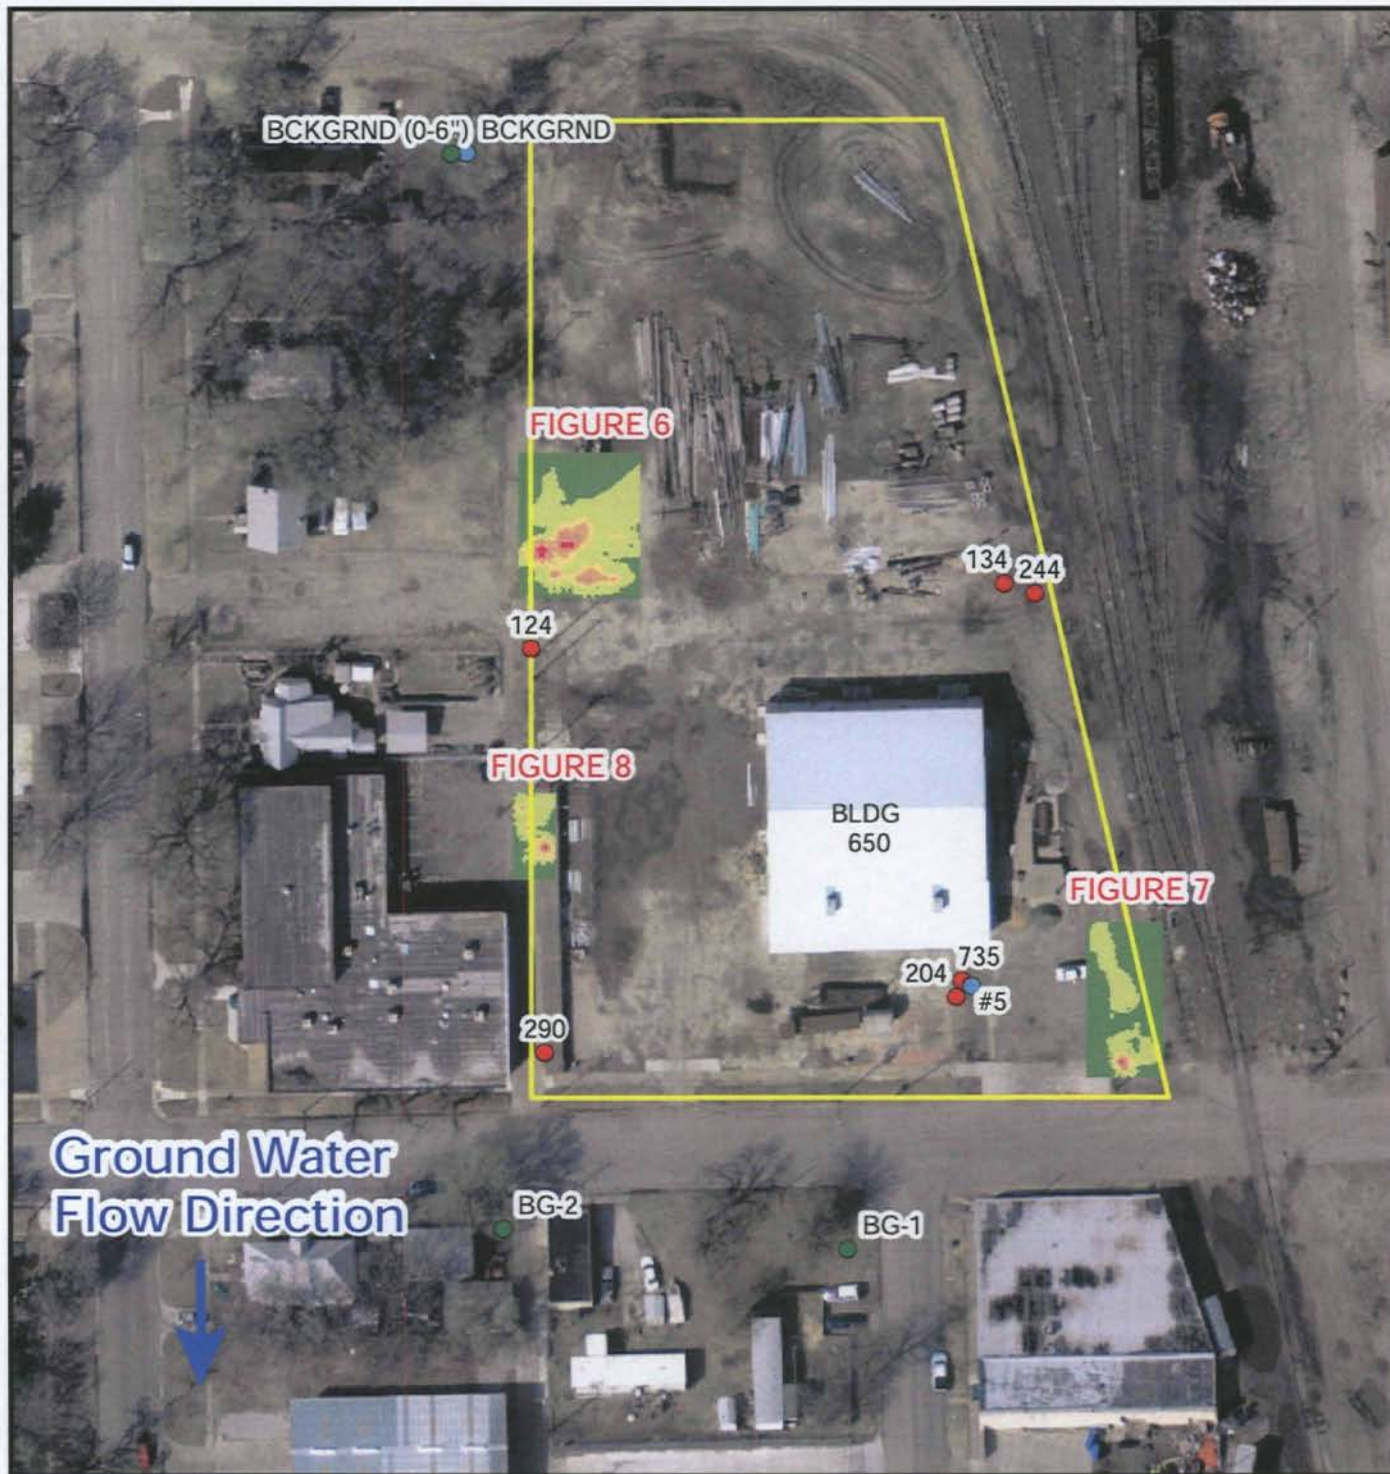
FIGURE 5

Soil samples numbered by sampling location and depth interval were obtained (see Table 4 for location rationale and sampling parameters), including one upgradient ground water and two upgradient soil background locations (see Figure 5). Completely filled Macro-core® core-barrel recovery was usually attained, although in some locations non-native material and/or voided sections were present in the core-barrel. Descriptions of sample visual soil characteristics and constituent lithology were recorded. The soil samples were double bagged in quart-sized plastic bags, labeled, and preserved on ice in a cooler until laboratory submission. A total of 24 soil samples were collected at the property consistent with KDHE standard operating procedure (SOP) BER-03. Soil samples were submitted to the laboratory for analysis of radium-226 using EPA Method 9315. The samples were field screened for radium-226 with a Ludlum model 2241-2 digital survey meter with a Ludlum model 44-2, one-inch diameter by one-inch thick, sodium iodide T1 scintillator probe. Soil samples were submitted to the laboratory for analysis of RCRA total metals using EPA Methods 6010 or 7471, as appropriate. The soil samples were also field screened for metals using X-ray fluorescence (XRF) analysis with an Innov-X X-ray tube analyzer. Appropriate initial standardization and standards were analyzed consistent with EPA Method 6200. The soil samples were field screened for VOCs using a Perkin-Elmer 2020 photoionization detector (PID) while contained in the acetate liner

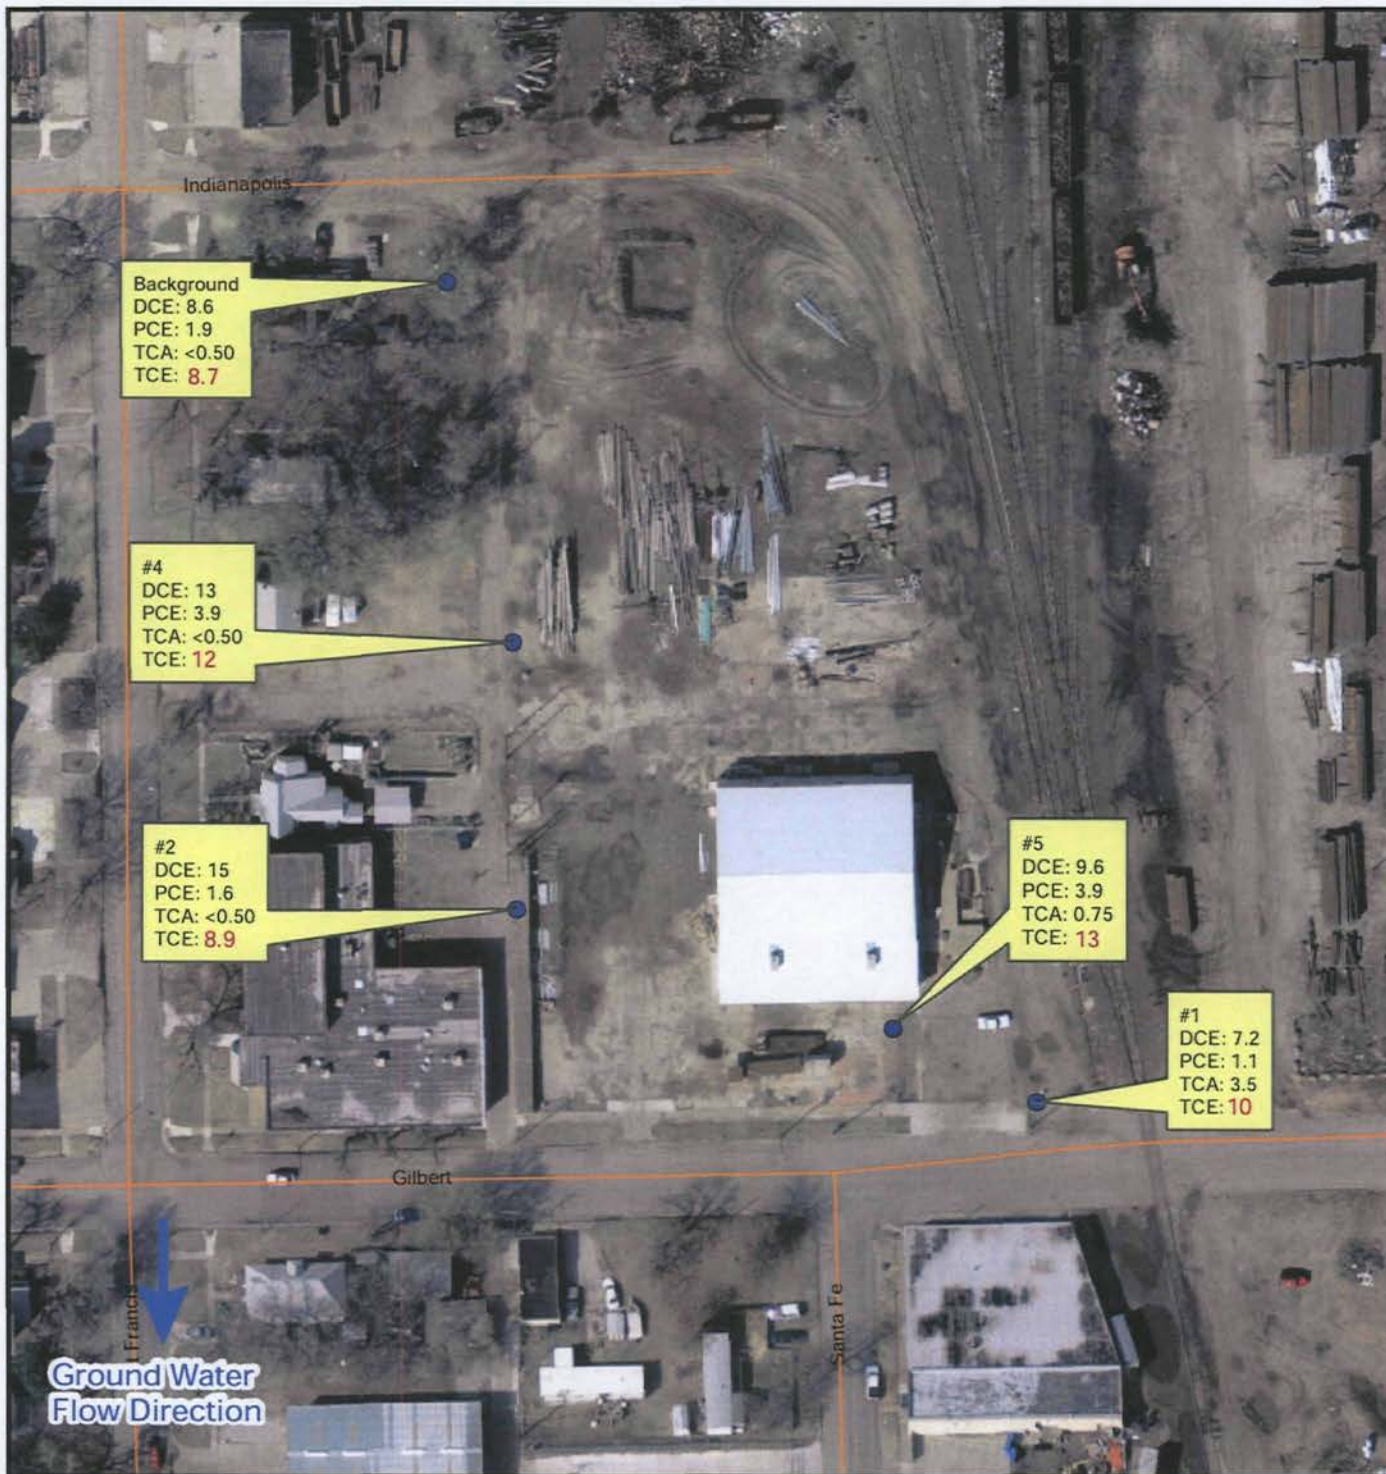
Radium-226 Laboratory Analytical Soil Results
Standard Products, Inc. (Former)
Wichita, Kansas

During the UFA, the maximum radium-226 laboratory detection in soil was 81,800 pCi/g, above its EPA/NRC screening level of 5 pCi/g plus background (using the maximum site-specific background result equates to 6.61 pCi/g). Elevated levels of lead, arsenic and cadmium were also identified in soils above RSK values. Multiple volatile organic compounds were identified in ground water, which is likely associated with the Gilbert and Mosley site. Radium-226 was identified in ground water above its MCL of 5 pCi/L at 156 pCi/L and appears to be attributable to the former Standard Products, Inc., facility.

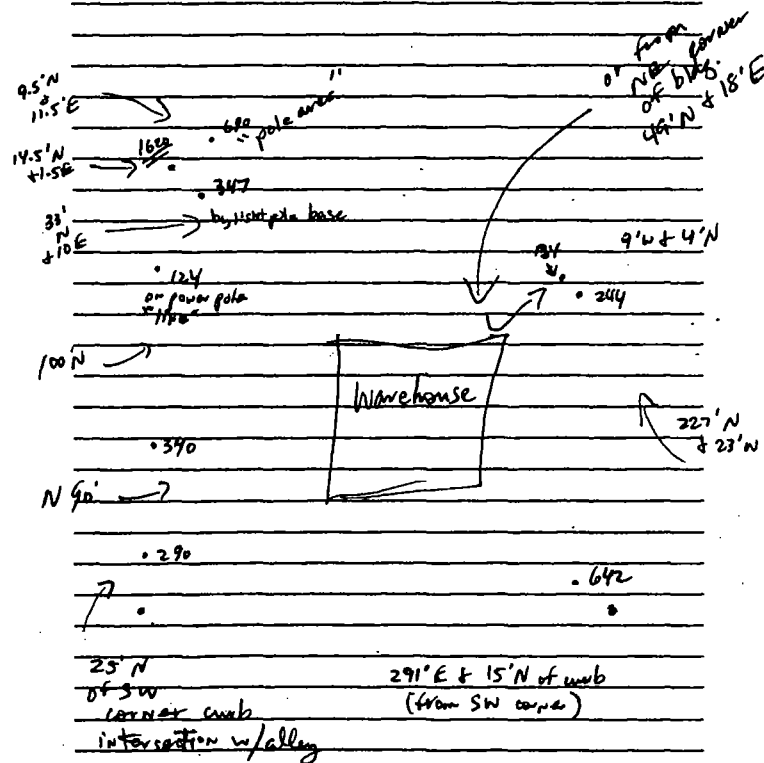
See map for readings
(= Figure 4)

units = mR/hr.

Calibrate Ludlum ≈ 538 mR/hr.check w/ neighbors yards for background
(n. of parking area for clinic) = 12 mR/hr.

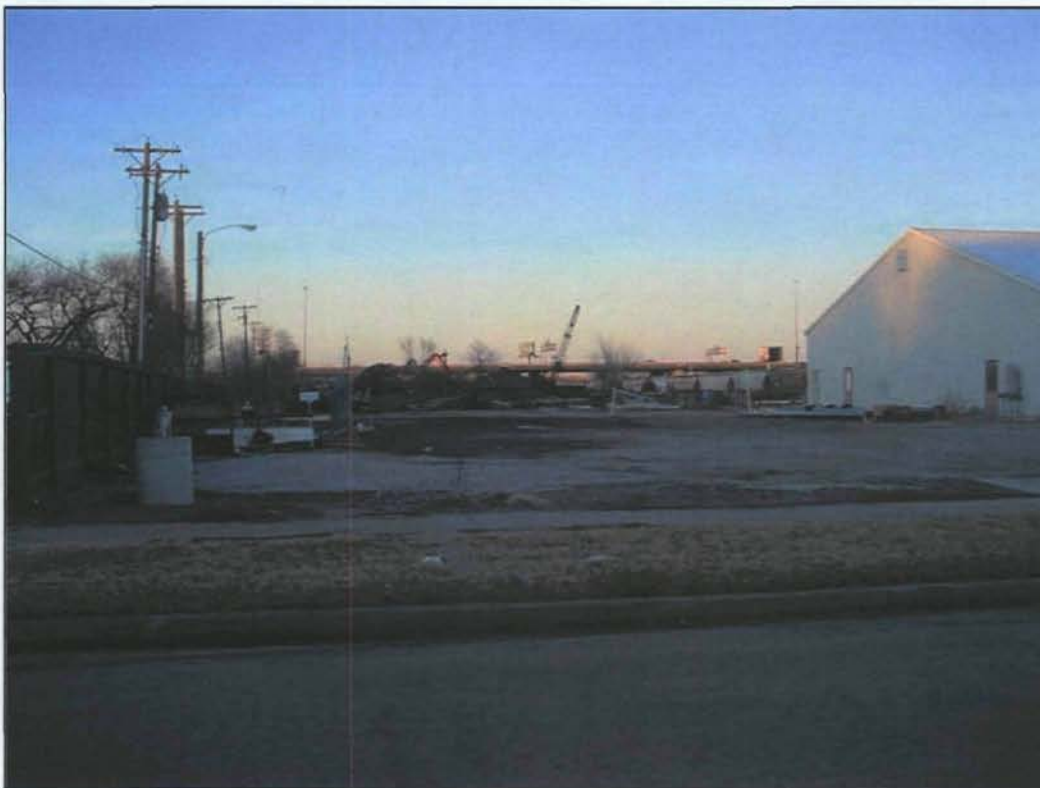
Photo # 1

View of western portion of the property. The lot is currently used for storage of power poles, light poles and electrical construction equipment/supplies. The warehouse/shop building is a newer structure.

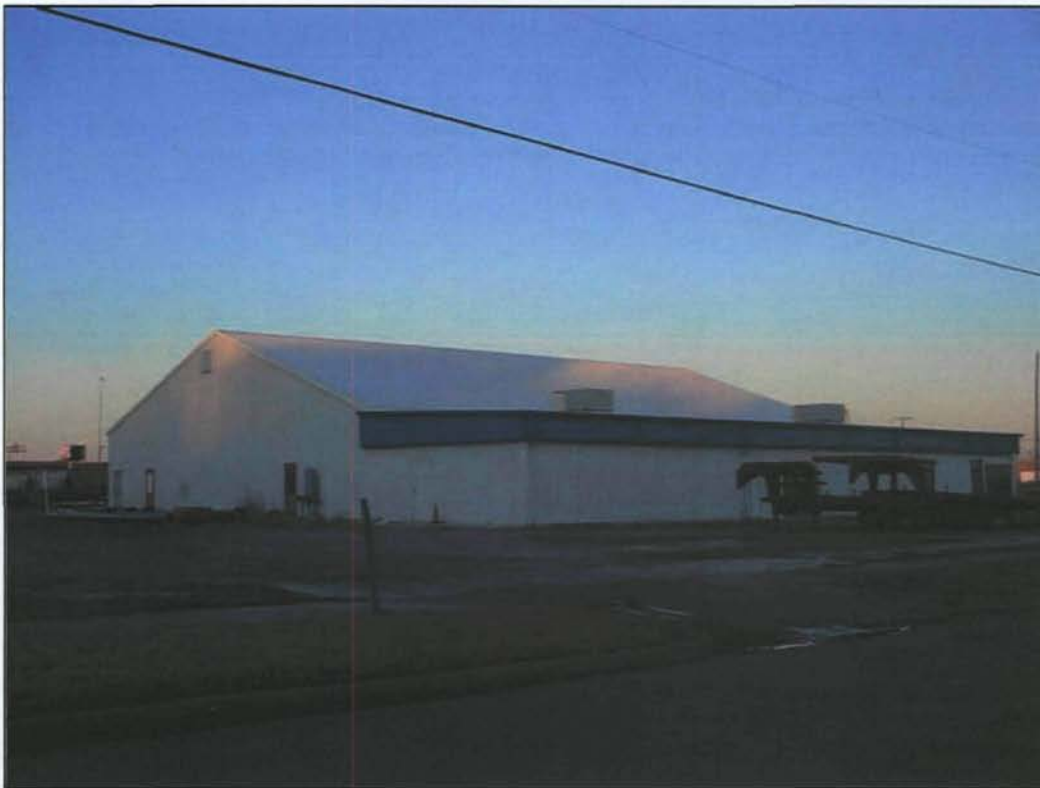
Photo # 2

Panning east from photo #1 view of building.

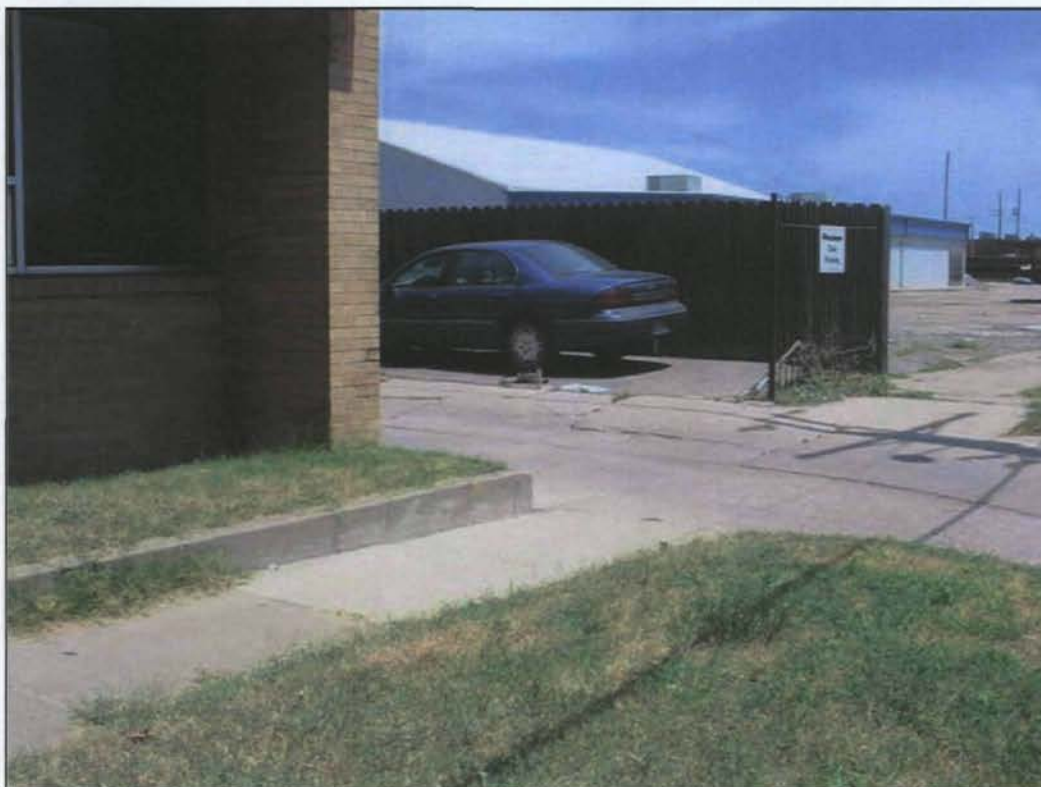
Photo # 3

View of SW corner area of property and bounding N-S oriented alley. Ludlum is marking a high radiation oval area in the alley (by rear tire of auto).

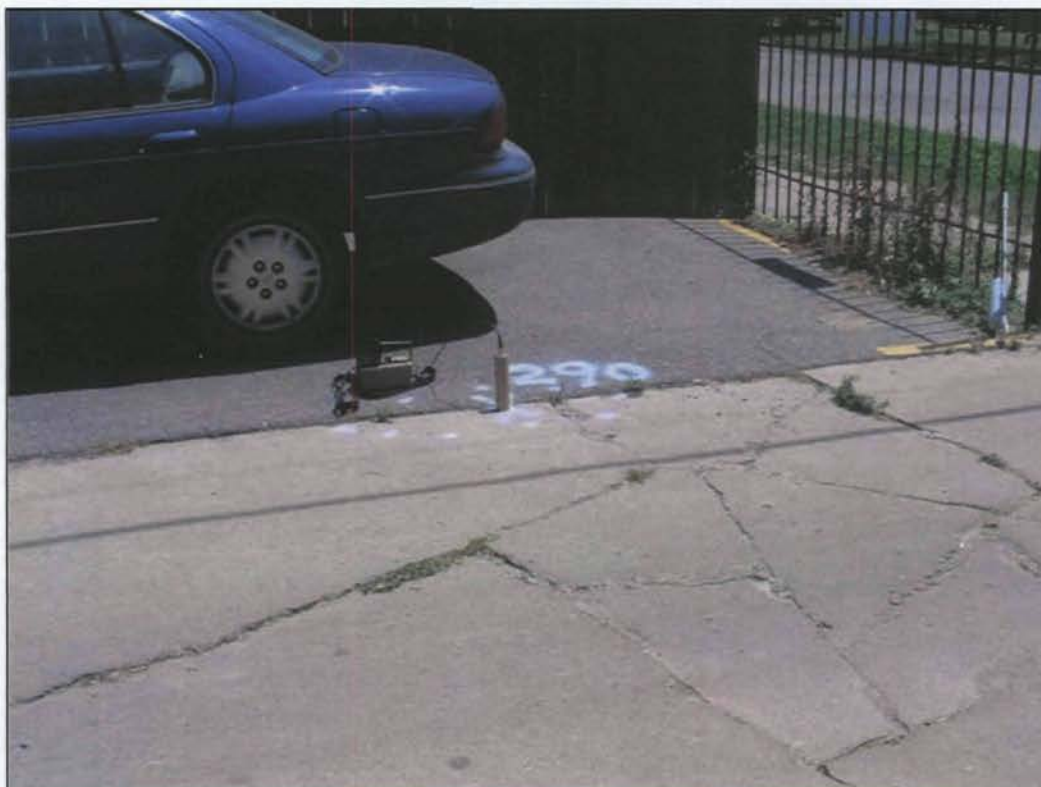
Photo # 4

Closeup of photo #3 showing high radiation area in alley.

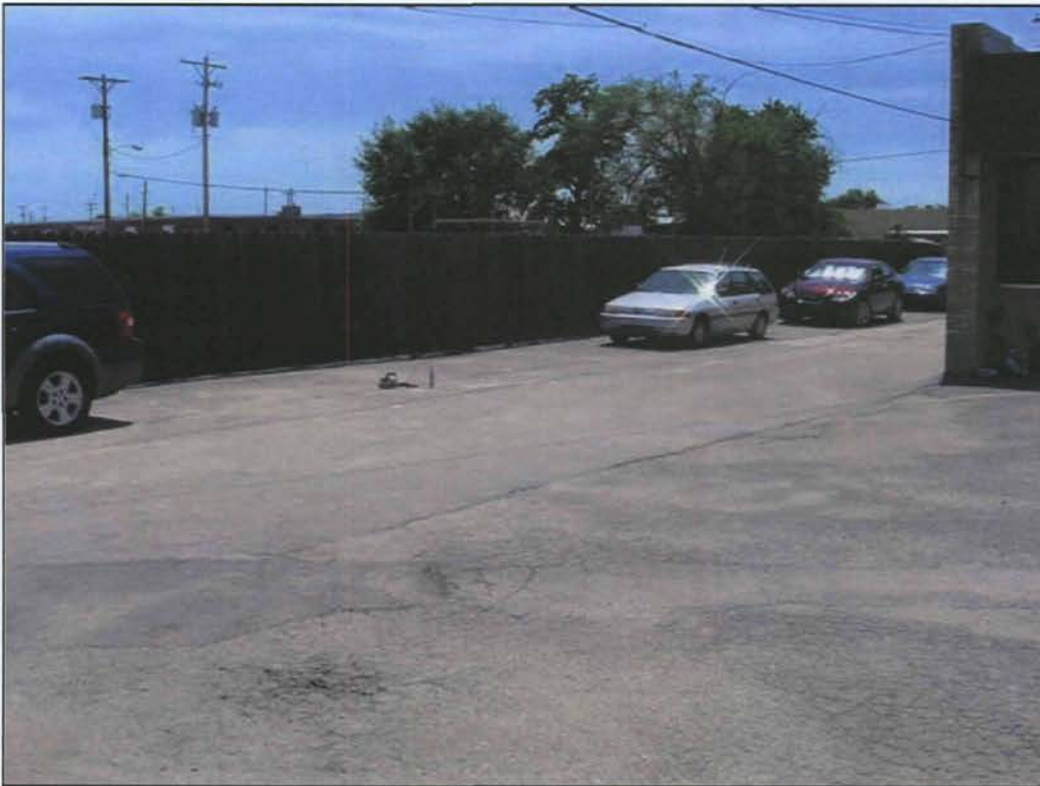
Photo # 5

Moving north up the alley is another area of high radiation marked by the Ludlum.

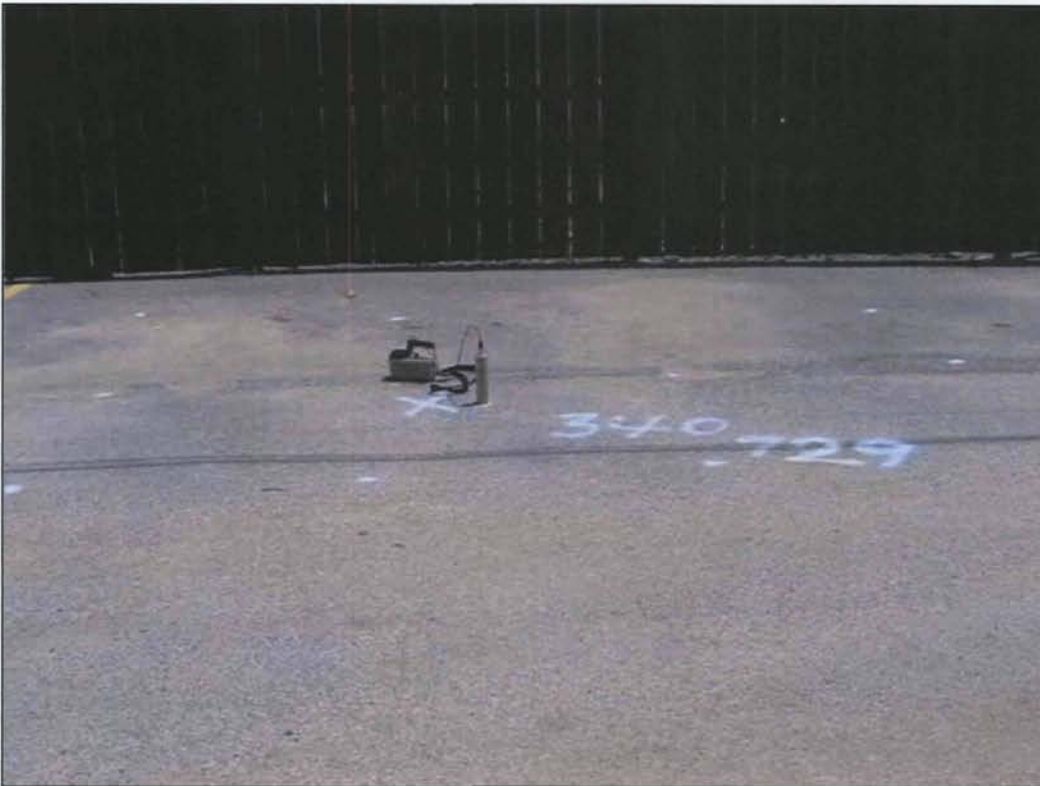
Photo # 6

Closeup of photo #5 showing an area of high radiation.

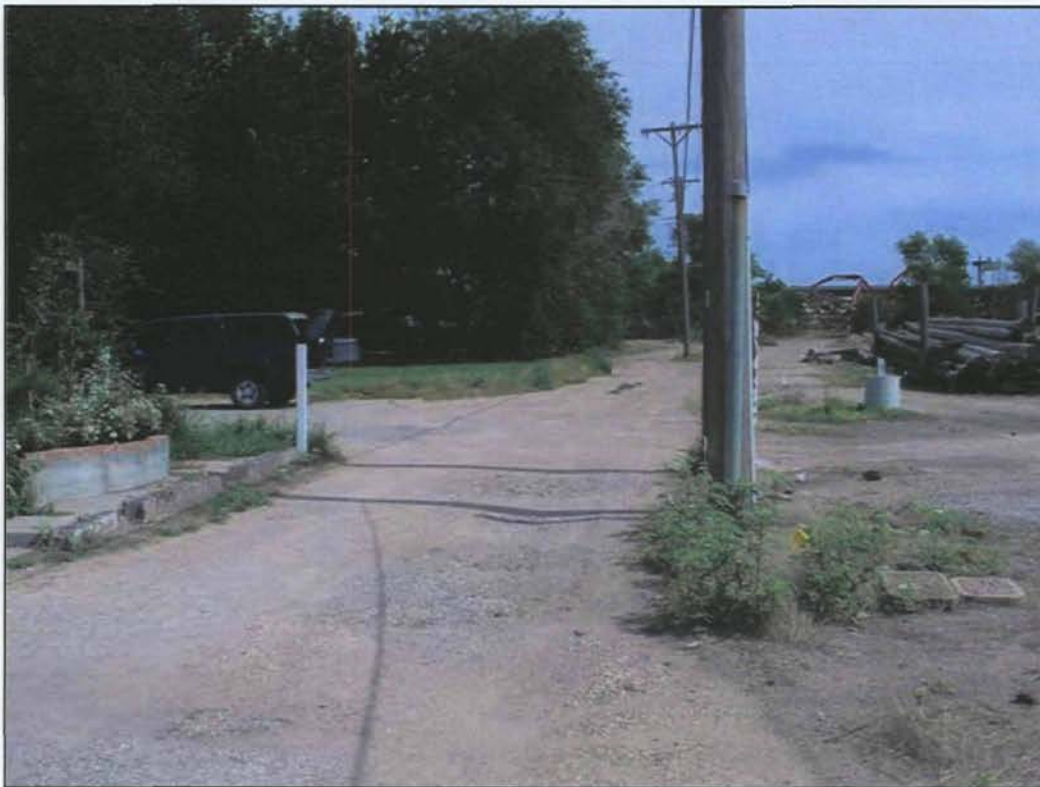
Photo # 7

View of alley north of photo #5 area. North background sampling location is just west of alley terminus (behind tree grove north of auto).

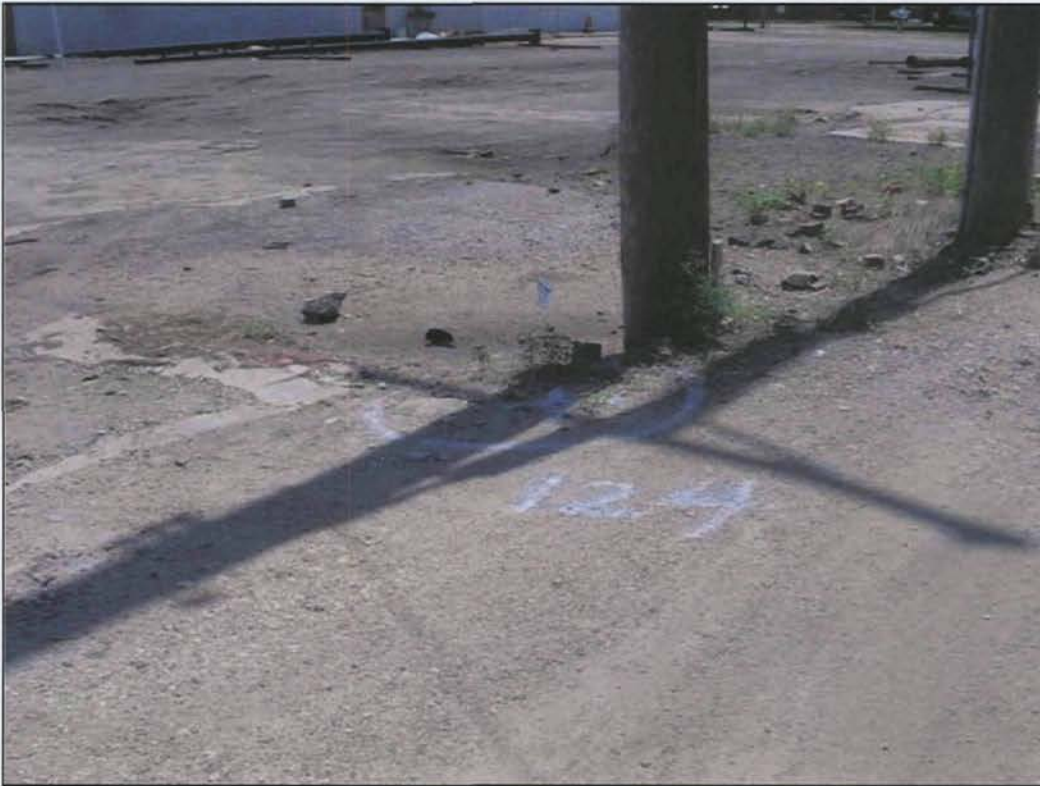
Photo # 9

Closeup of photo #8 showing a circular area of high radiation.

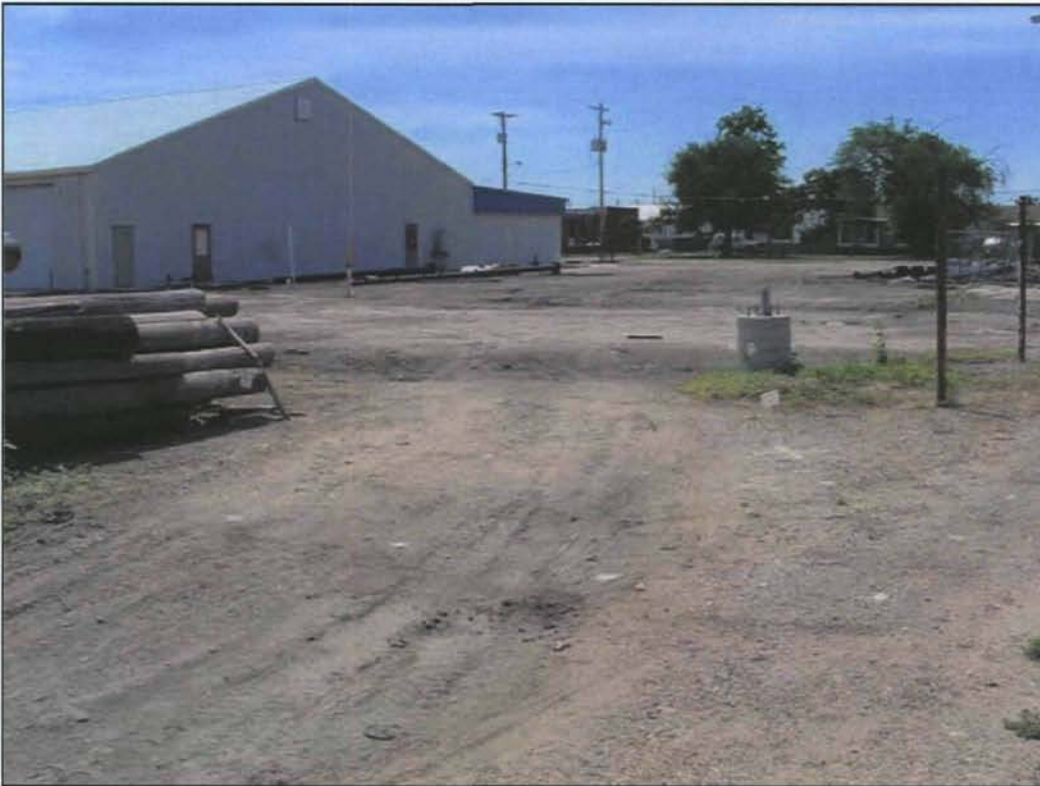
Photo # 10

View from further north up the alley showing a larger area of spotty radiation contamination. Note white flags by concrete light pole base and a flag by the stacked power pole terminus.

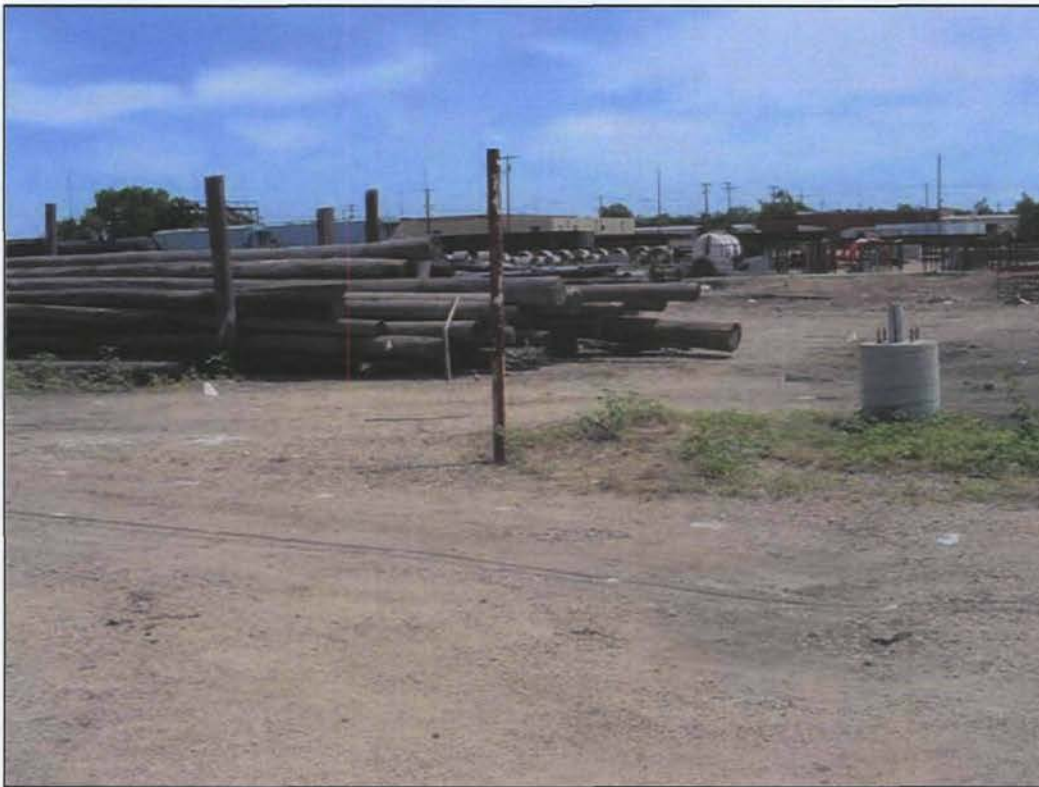
Photo # 11

Different view of photo #10 area.

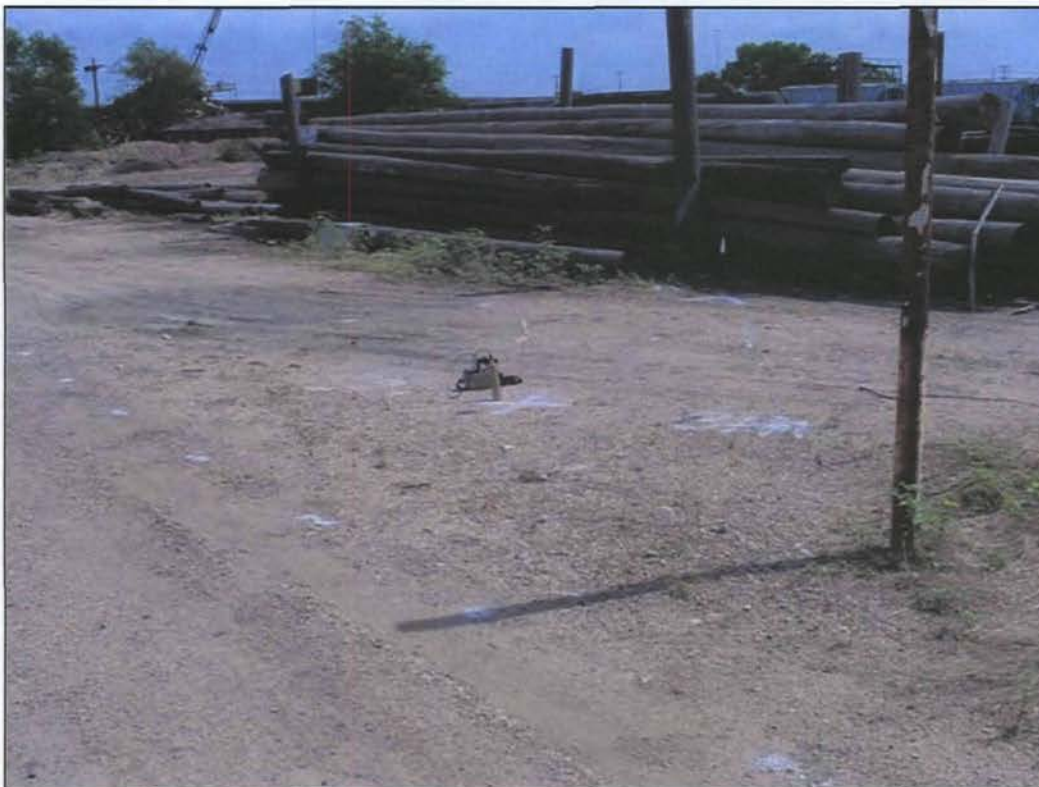
Photo # 12

Another view of photo #10 area. Ludlum in bare area, white flag just NE of Ludlum, and white flag near power pole stack mark spots of high radiation.

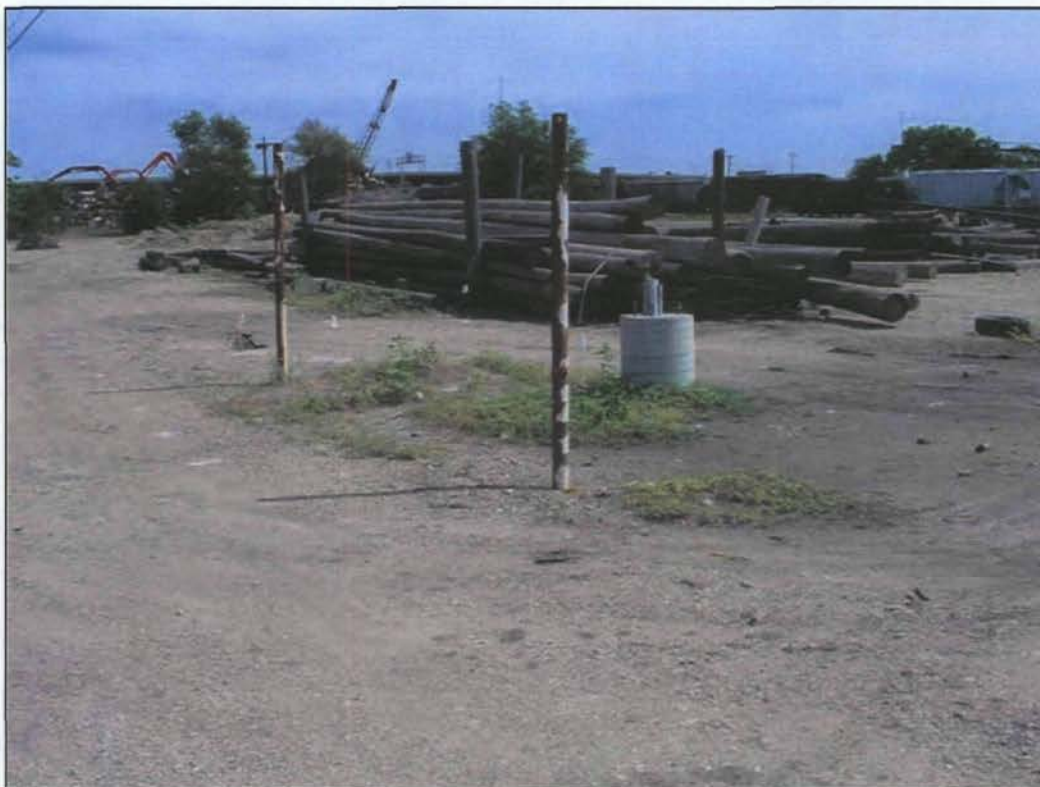
Photo # 13

View of northern part of alley area.

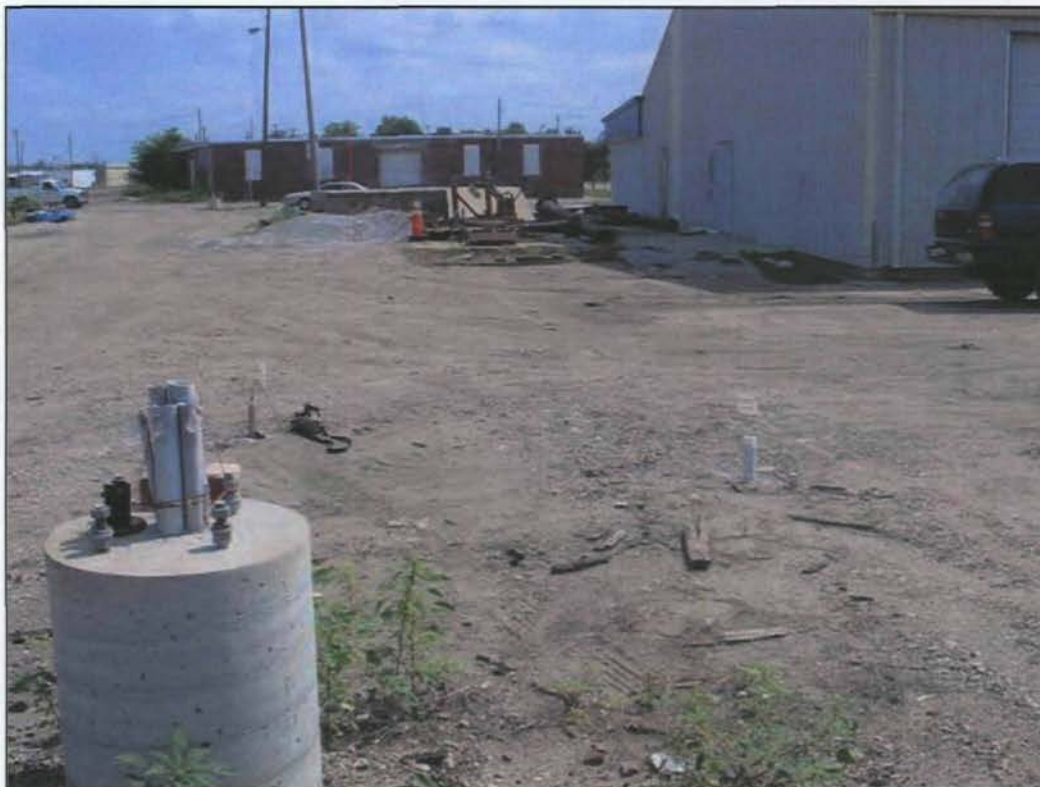
Photo # 14

View of an area NE of building showing two high radiation spots. This view shows the eastern "alley-railroad right-of-way" boundary of the property.

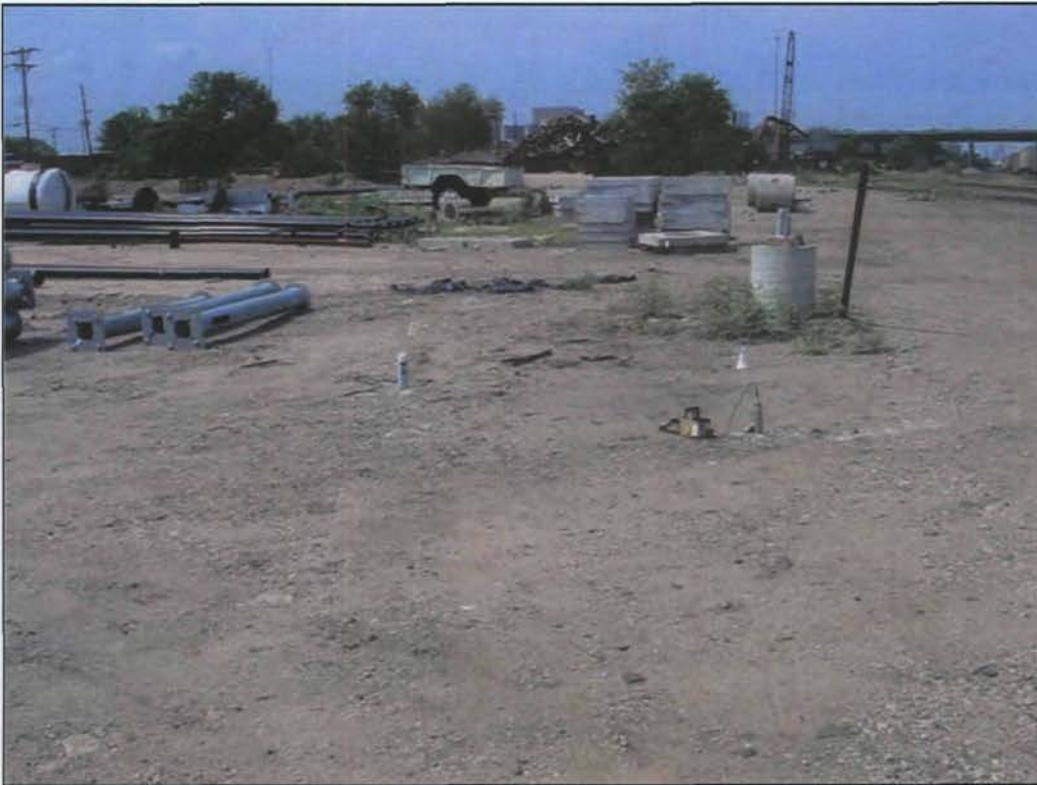
Photo # 15

View of an area NE of the building showing two spots of high radiation (paint can with white flag and Ludlum with white flag mark the spots).

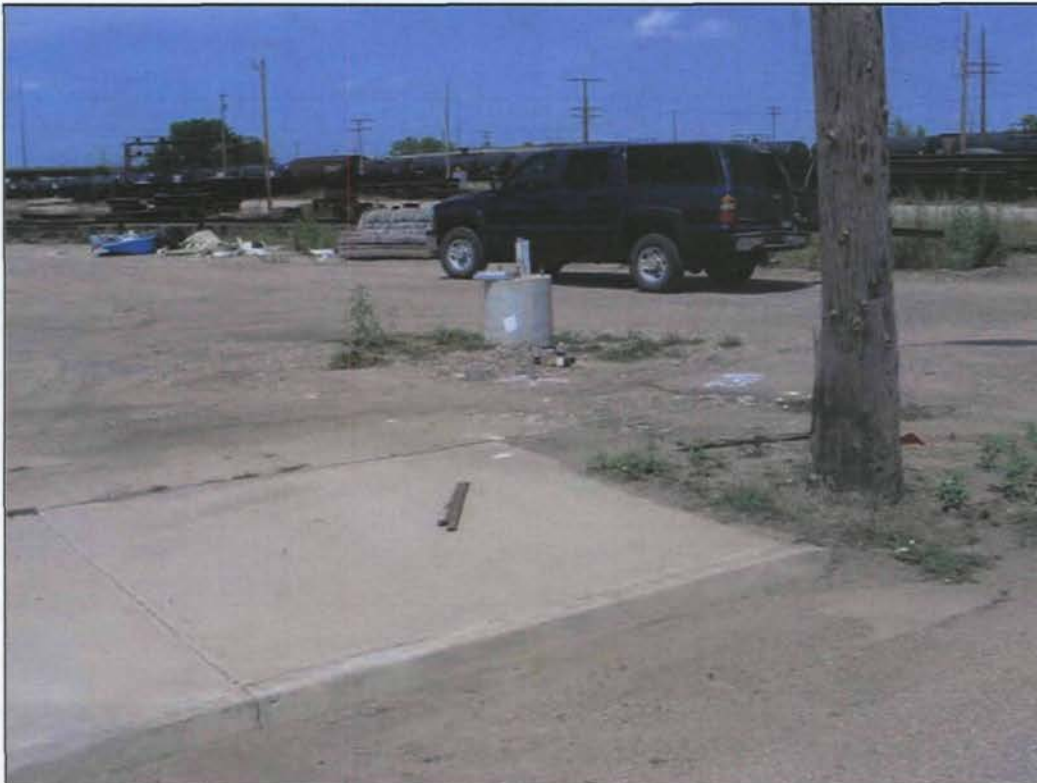
Photo # 16

SE corner area of property. White flag in front of concrete light pole base marks an oval high radiation area.

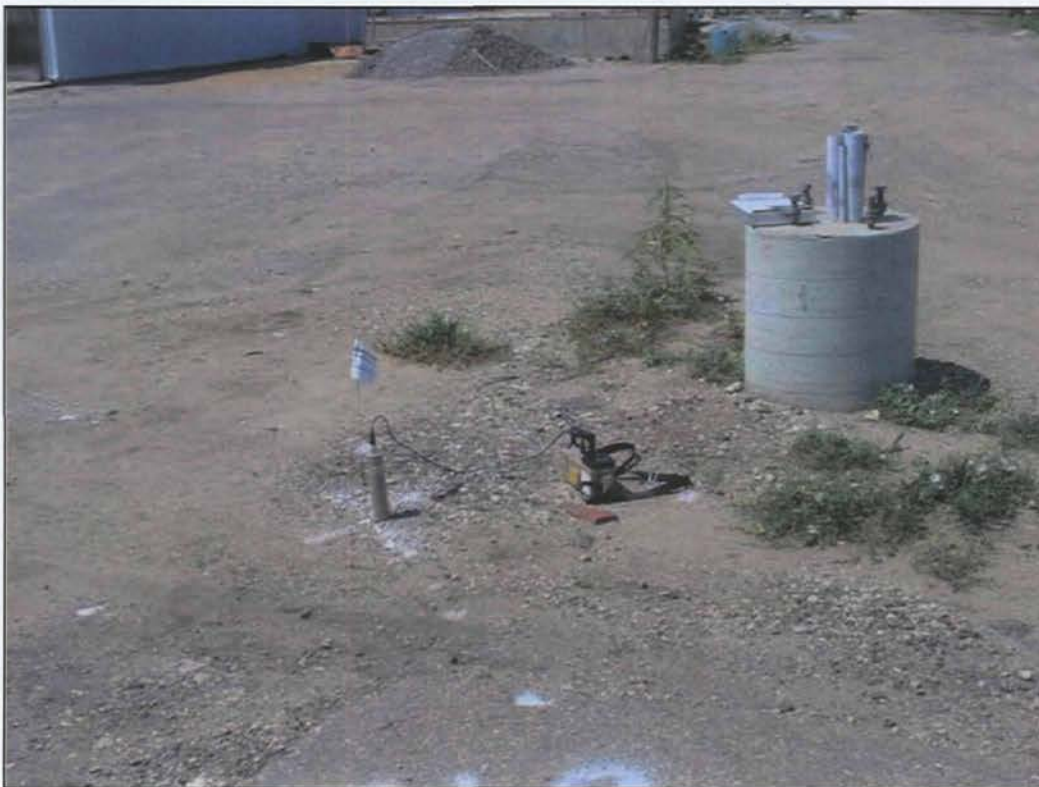
Photo # 17

Closeup of photo #16 .
